HP LaserJet Family
Quick Reference
Service Guide

Volume I

Publication number
5021-8943

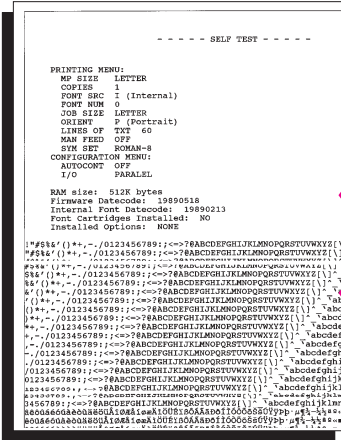
Description: On rare occasions, you may see compressed print on a LaserJet IIP. The print may be compressed anywhere on the page. It may look like text compressed into a thin line or appear as a gap between lines. Troubleshooting can be difficult because the problem is usually intermittent.

Figure 9-5 Gap between lines and compressed line on the same page

Solution: Replace the drum drive gear assembly, part number RG1-1777-000CN.
